FINAL REPORT *OF* A BOARD OF INVESTIGATION

*To Inquire Into*  
THE DESIGN  
AND METHODS OF CONSTRUCTION  
OF WELDED STEEL MERCHANT  
VESSELS

15 JULY 1946

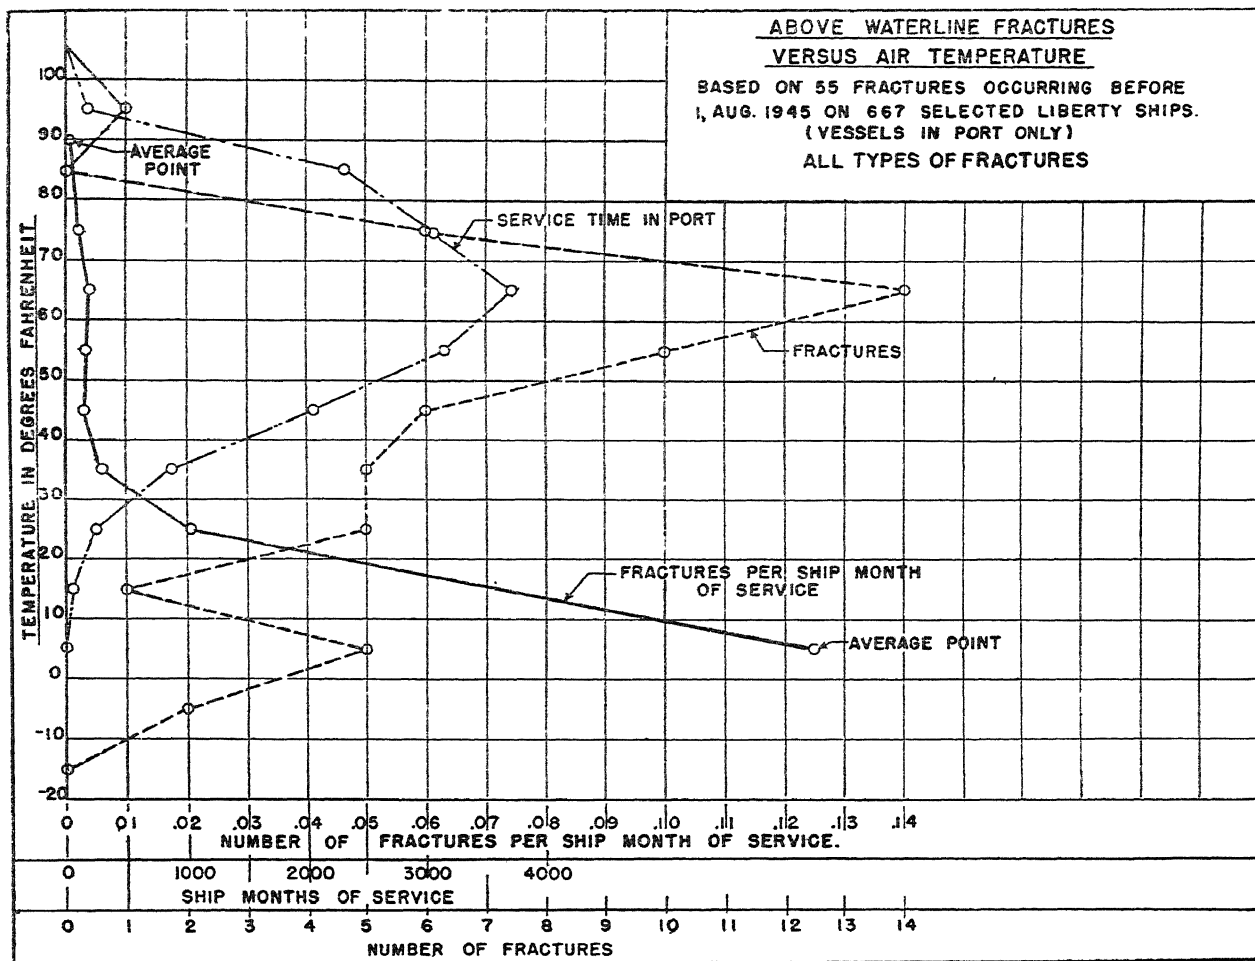
Figure 26.

and state of sea in such a manner that they would withstand a rigorous statistical appraisal. It was possible, however, to eliminate entirely the effect of sea in a study which was made on ships in port only. The results of this study are presented in figure 26

and show the distribution of service time and fractures for various air temperature ranges. This plot includes Class 1, 2 and 3 fractures for the above water line portion of the hull as well as an indication of the risk of casualty in terms of casualty per ship months of service time; all curves are plotted against air temperature ranges.

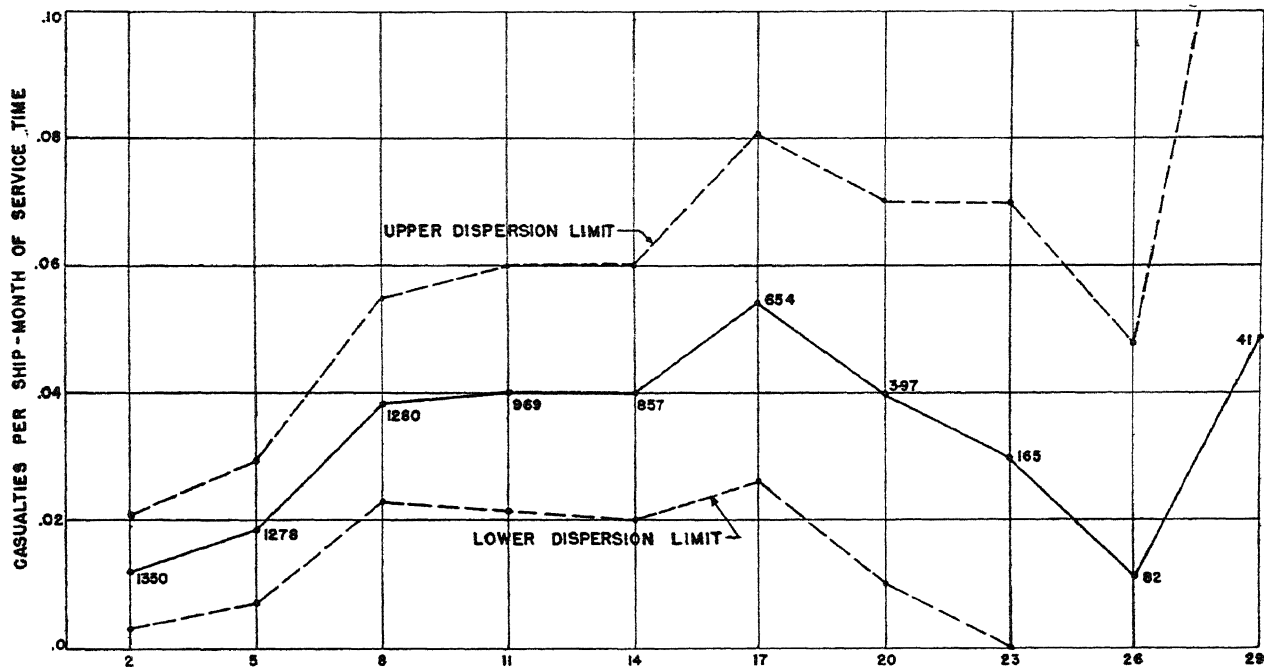
AGE AT CASUALTY  
Figure 27.

The date and age data, table II, permit study in many different ways. A sample plotting of winter casualties, figure 27, shows that casualty rate is not appreciably affected by age. Summer casualties are very few and show no anomalies. Other divisions by season may be plotted ad lib but most of the casualties were in winter.

The upper and lower dispersion limits are shown on figures 27 and 28. These limits are established on the basis of probability so that 99 out of 100 similar findings could be expected to fall between them.

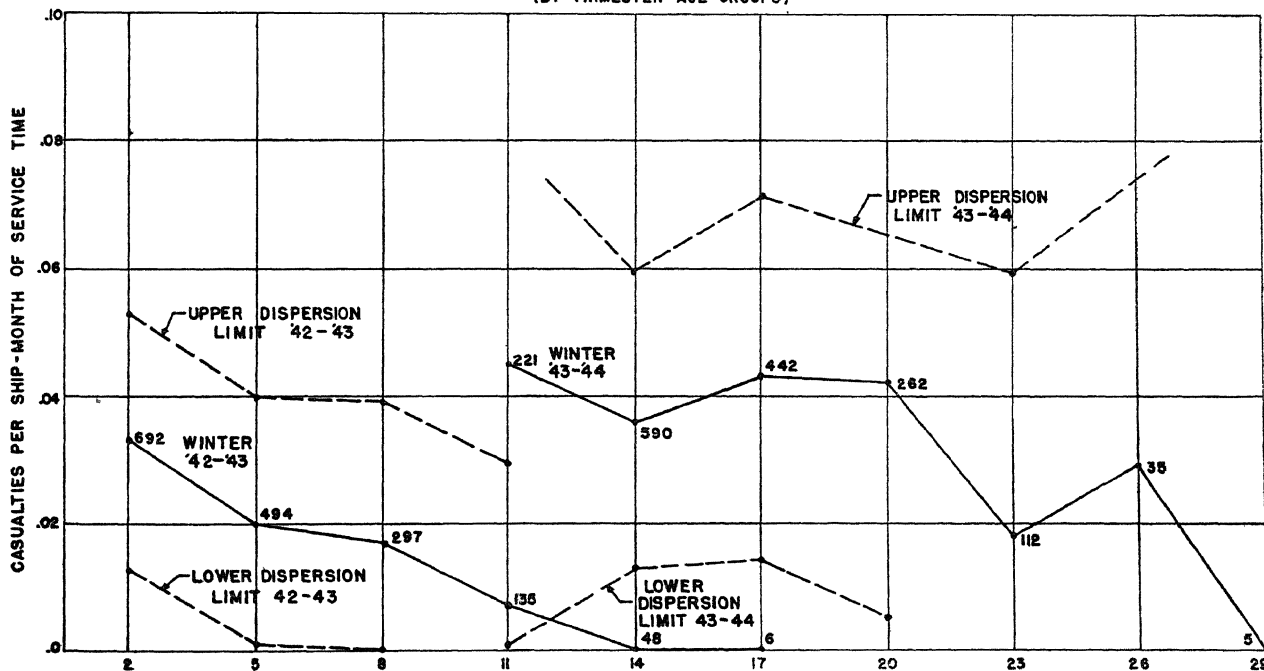
AGE AT CASUALTY  
Figure 28.

The effects of structural alterations on the "667 Liberties" are eliminated by deleting each ship from the list at the time the alterations were made, table III. Thus greater homogeneity of the date and age data on these ships permits further analysis. Although the curves, figure 28, show risk diminishing as age increases, such a conclusion would be hasty. This trend might be explained in several different ways; as by decreasing quality in ship construction practices, increasing notch sensitivity in the steel, or the selective assignment of missions to different categories of ships, there is no way of disentangling these influences. In any case, it is not to be regarded as an effect of elimination from the category of ships especially subject to casualty (lemons).

One conclusion which might be drawn from the curves for winters 1942-43 and 1943-44 is that the conditions to which the ships were exposed in the second of these were notably more severe than in the first.

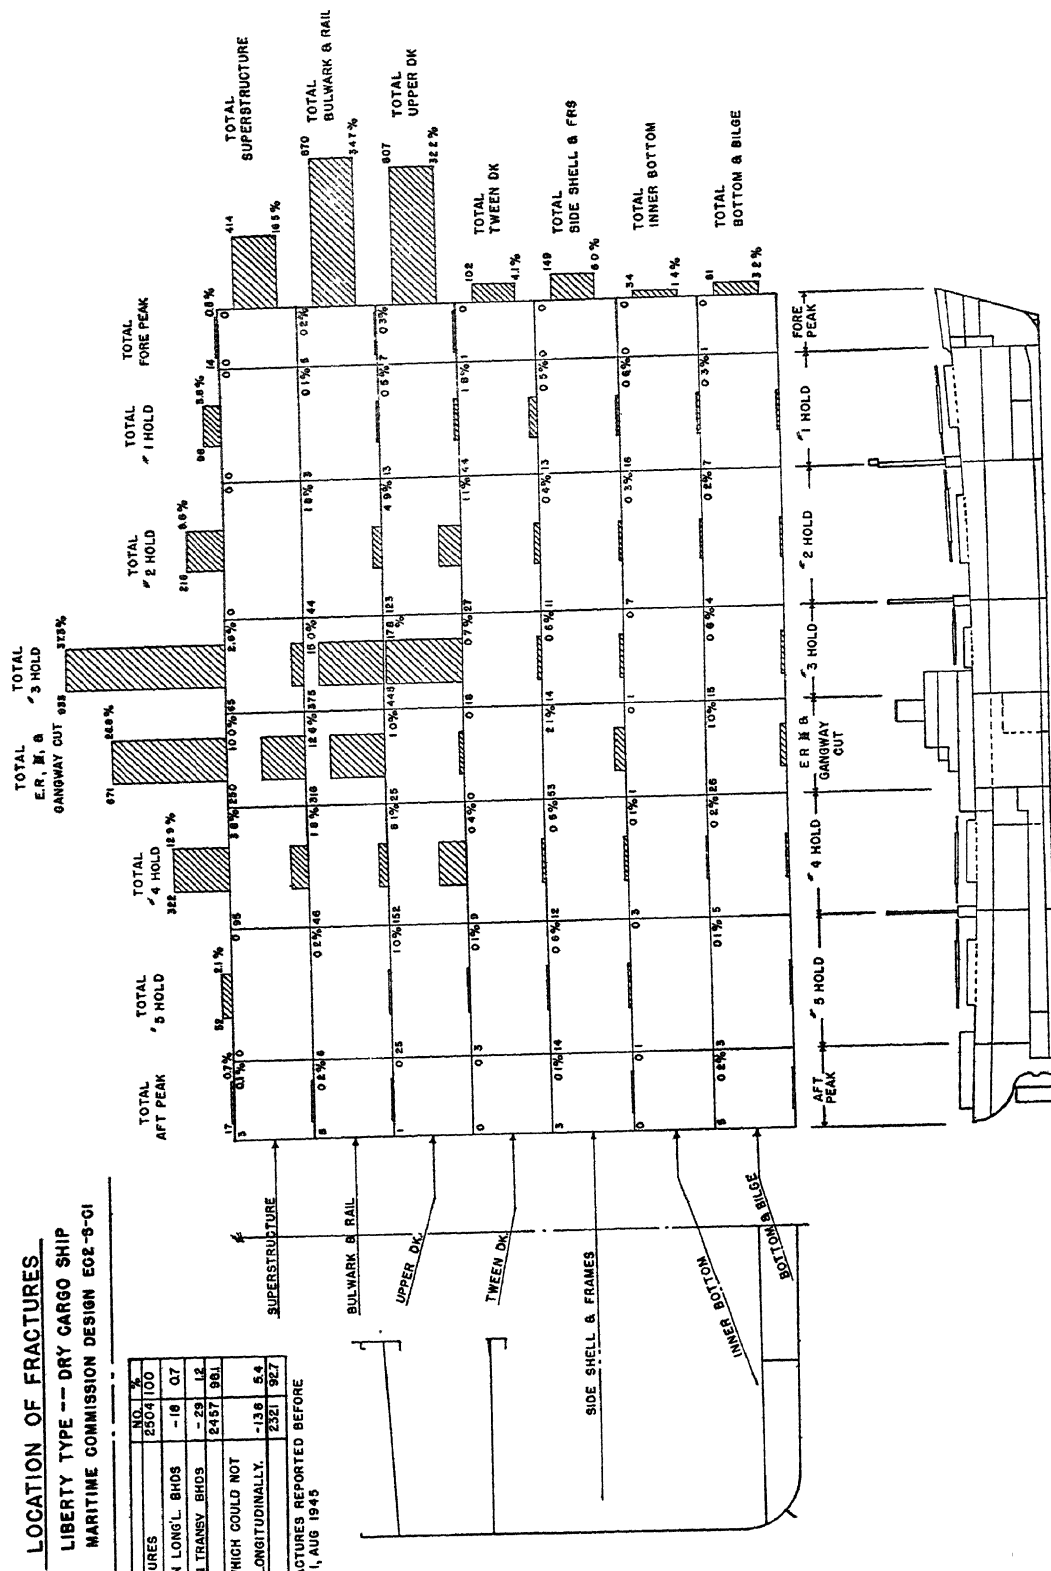
**Figure 30.**

**NOTE:** NUMBER IN THE UPPER LEFT CORNER OF EACH SQUARE INDICATES THE NUMBER OF FRACTURES THAT HAVE OCCURRED IN THAT PARTICULAR SECTION OF VESSEL. THE NUMERAL IN THE UPPER RIGHT CORNER INDICATES THE PER CENT OF THE TOTAL FRACTURES OF ALL SECTIONS (85041)

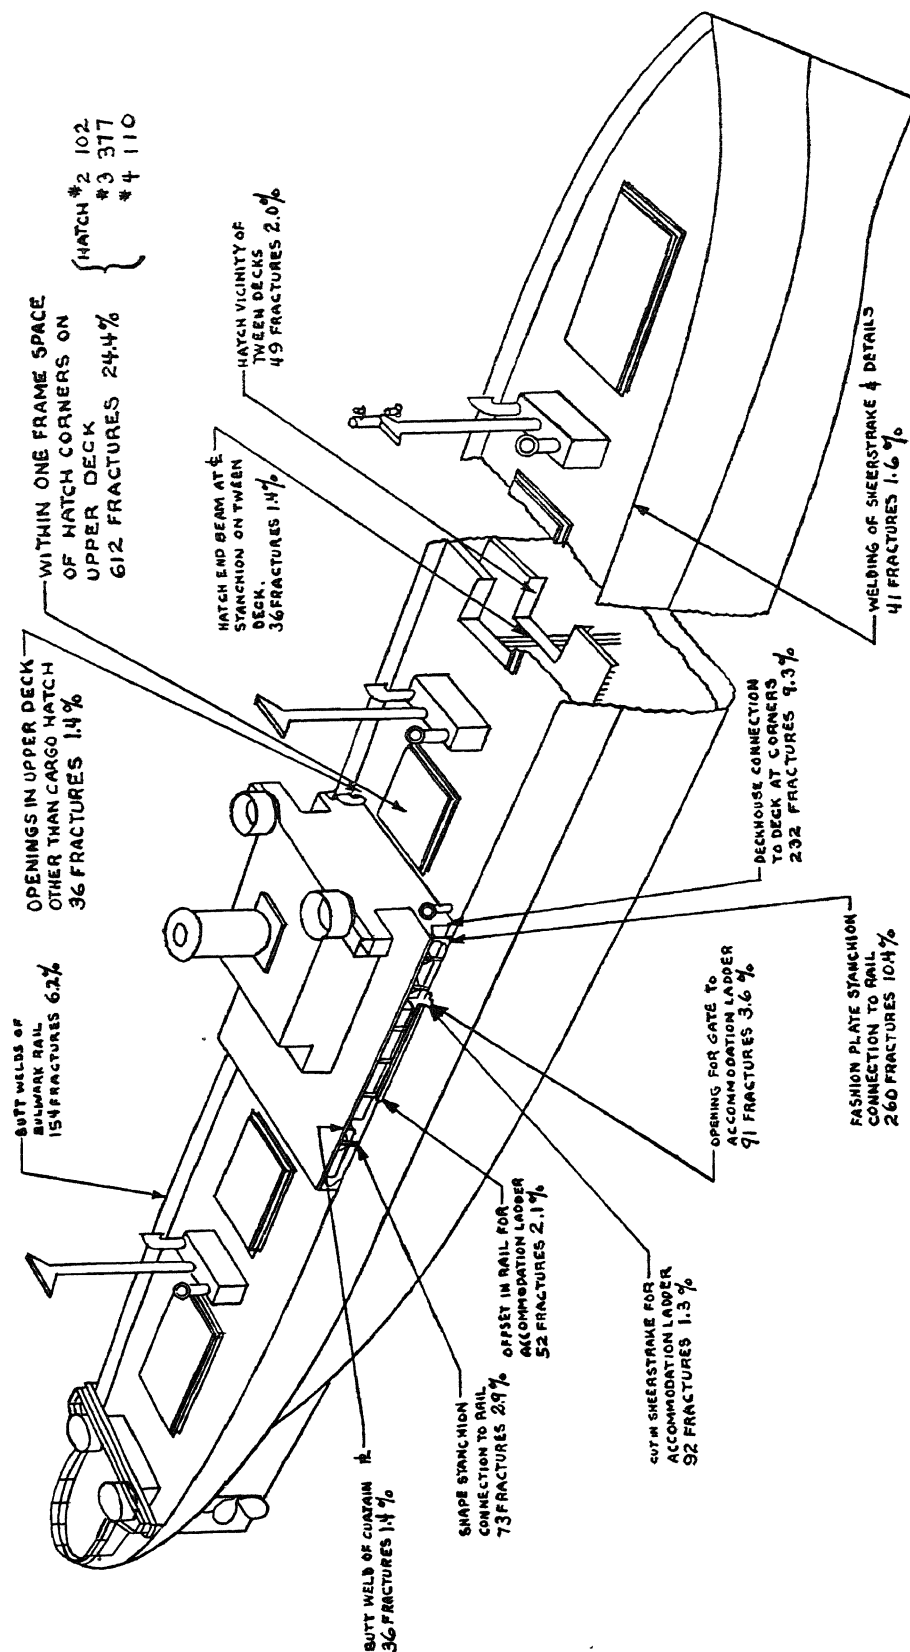
Figure 81.

DETAILS WITH ABNORMAL FREQUENCY OF FRACTURES  
THESE DATA INCLUDE 2504 FRACTURES OF KNOWN  
ORIGIN, OCCURRING BEFORE 1 AUG. 45. 158 OTHER  
FRACTURES OF INDEFINITE ORIGIN WERE REPORTED

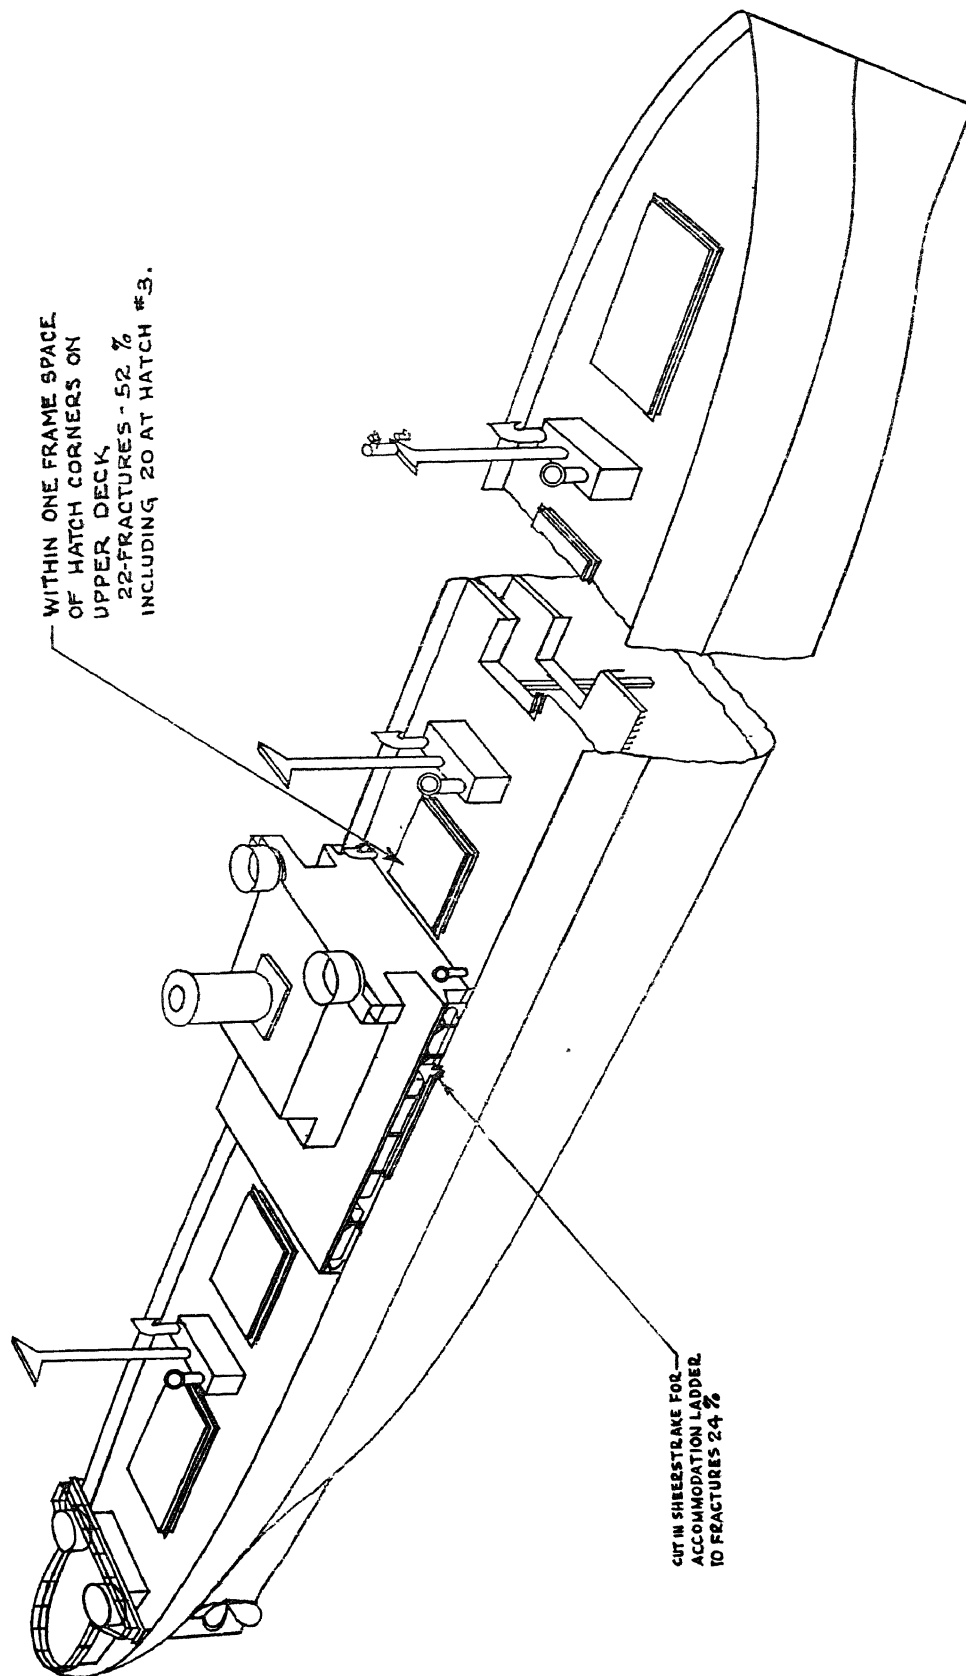
Figure 32.

DETAILS WITH ABNORMAL FREQUENCY OF FRACTURES  
THESE DATA INCLUDE, 4-2 FRACTURES OF KNOWN  
ORIGIN, OCCURRING BEFORE 1 AUG. 45, AND WHICH  
RESULTED IN CLASS 1 CASUALTIES

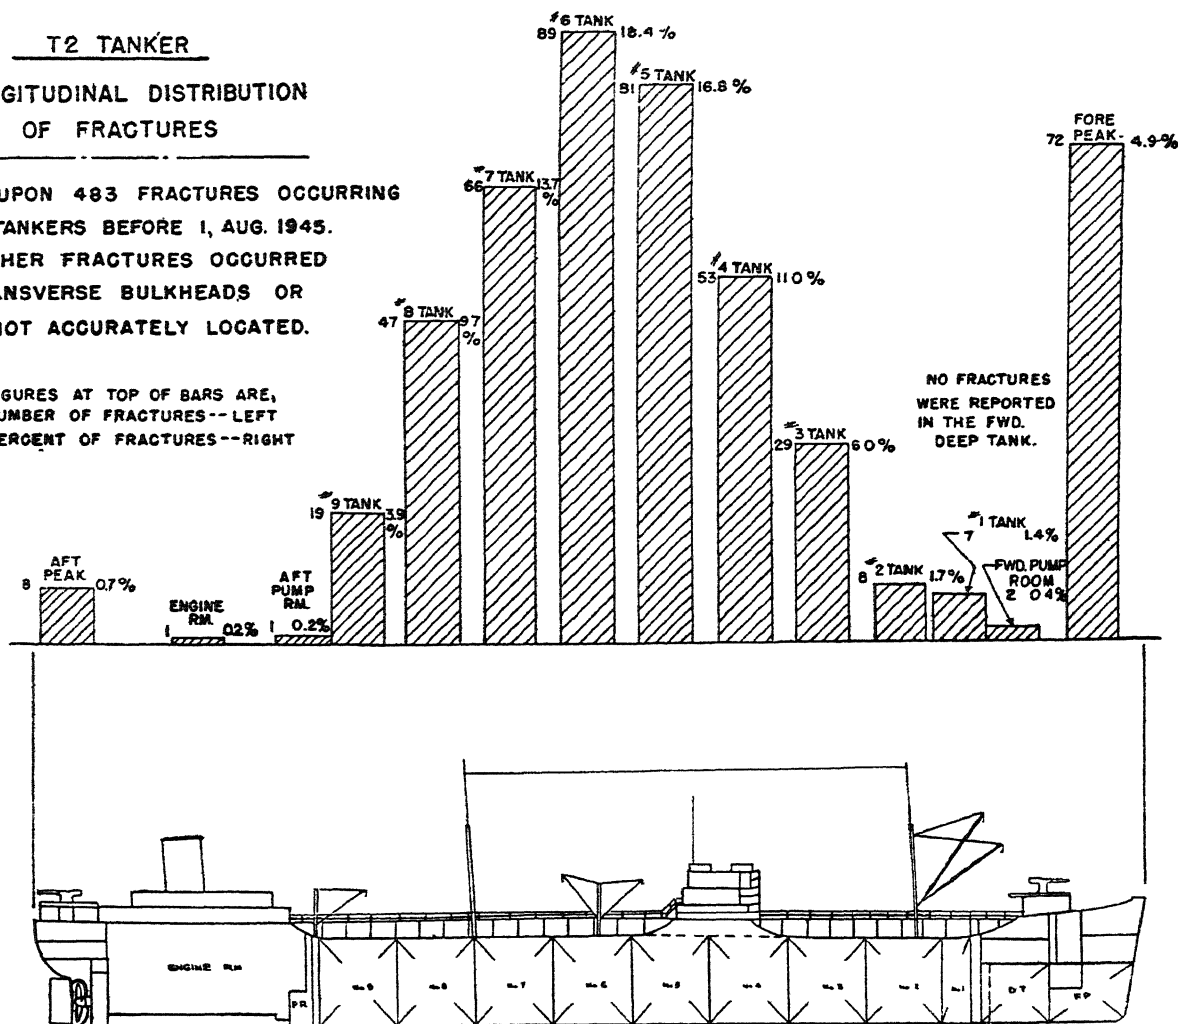
Figure 37.

BASED UPON 483 FRACTURES OCCURRING  
ON T2 TANKERS BEFORE 1, AUG. 1945.  
456 OTHER FRACTURES OCCURRED  
ON TRANSVERSE BULKHEADS OR  
WERE NOT ACCURATELY LOCATED.

The longitudinal distribution of the fractures on the T2 Tankers also shows a peak amidships indicating that bending of the hull is partly responsible for their occurrence, figure 37. All of the nine serious casualties occurred in Nos. 3, 4, 5, 6, and 7 tanks.

The large number of fractures in the forepeak indicated in figure 37 have involved many details of the internal structure. They are local in nature.

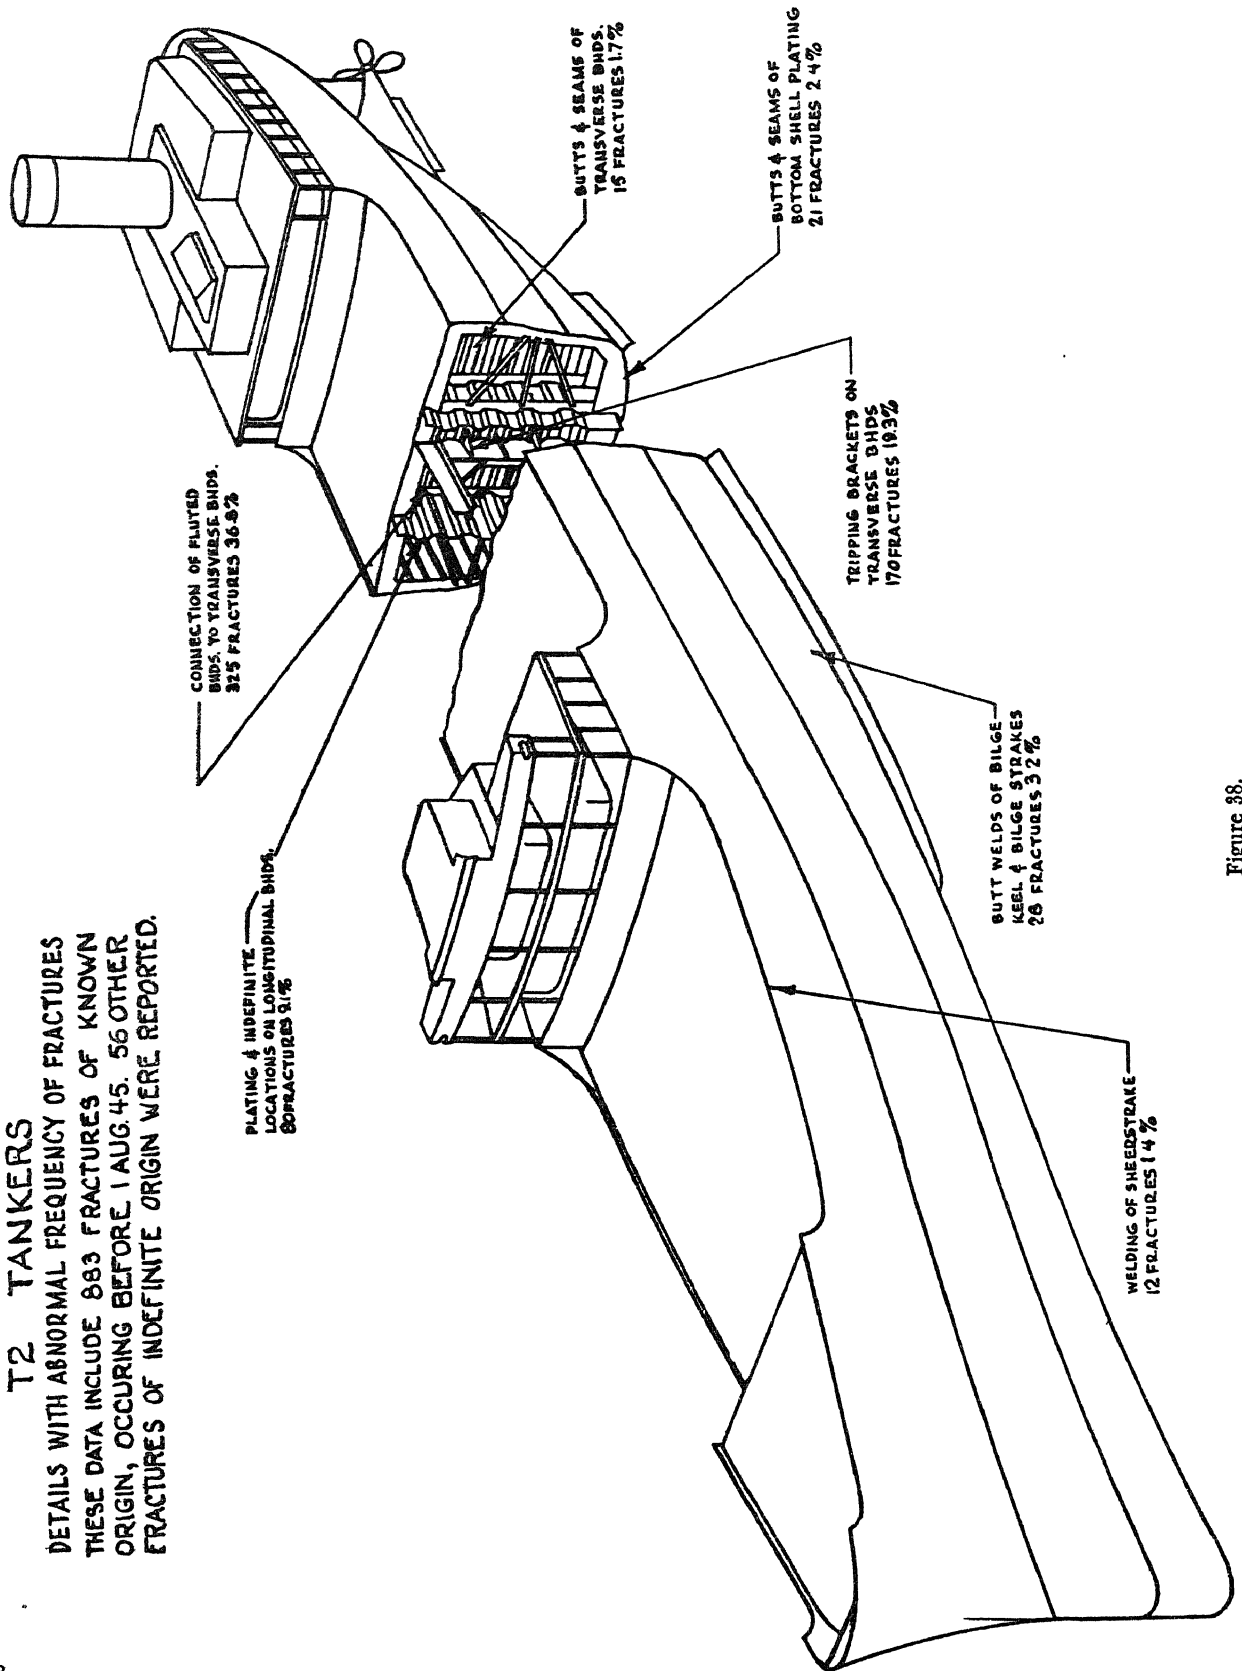
Figure 38.

DETAILS WITH ABNORMAL FREQUENCY OF FRACTURES  
THESE DATA INCLUDE 883 FRACTURES OF KNOWN  
ORIGIN, OCCURRING BEFORE 1 AUG. 45. 56 OTHER  
FRACTURES OF INDEFINITE ORIGIN WERE REPORTED.

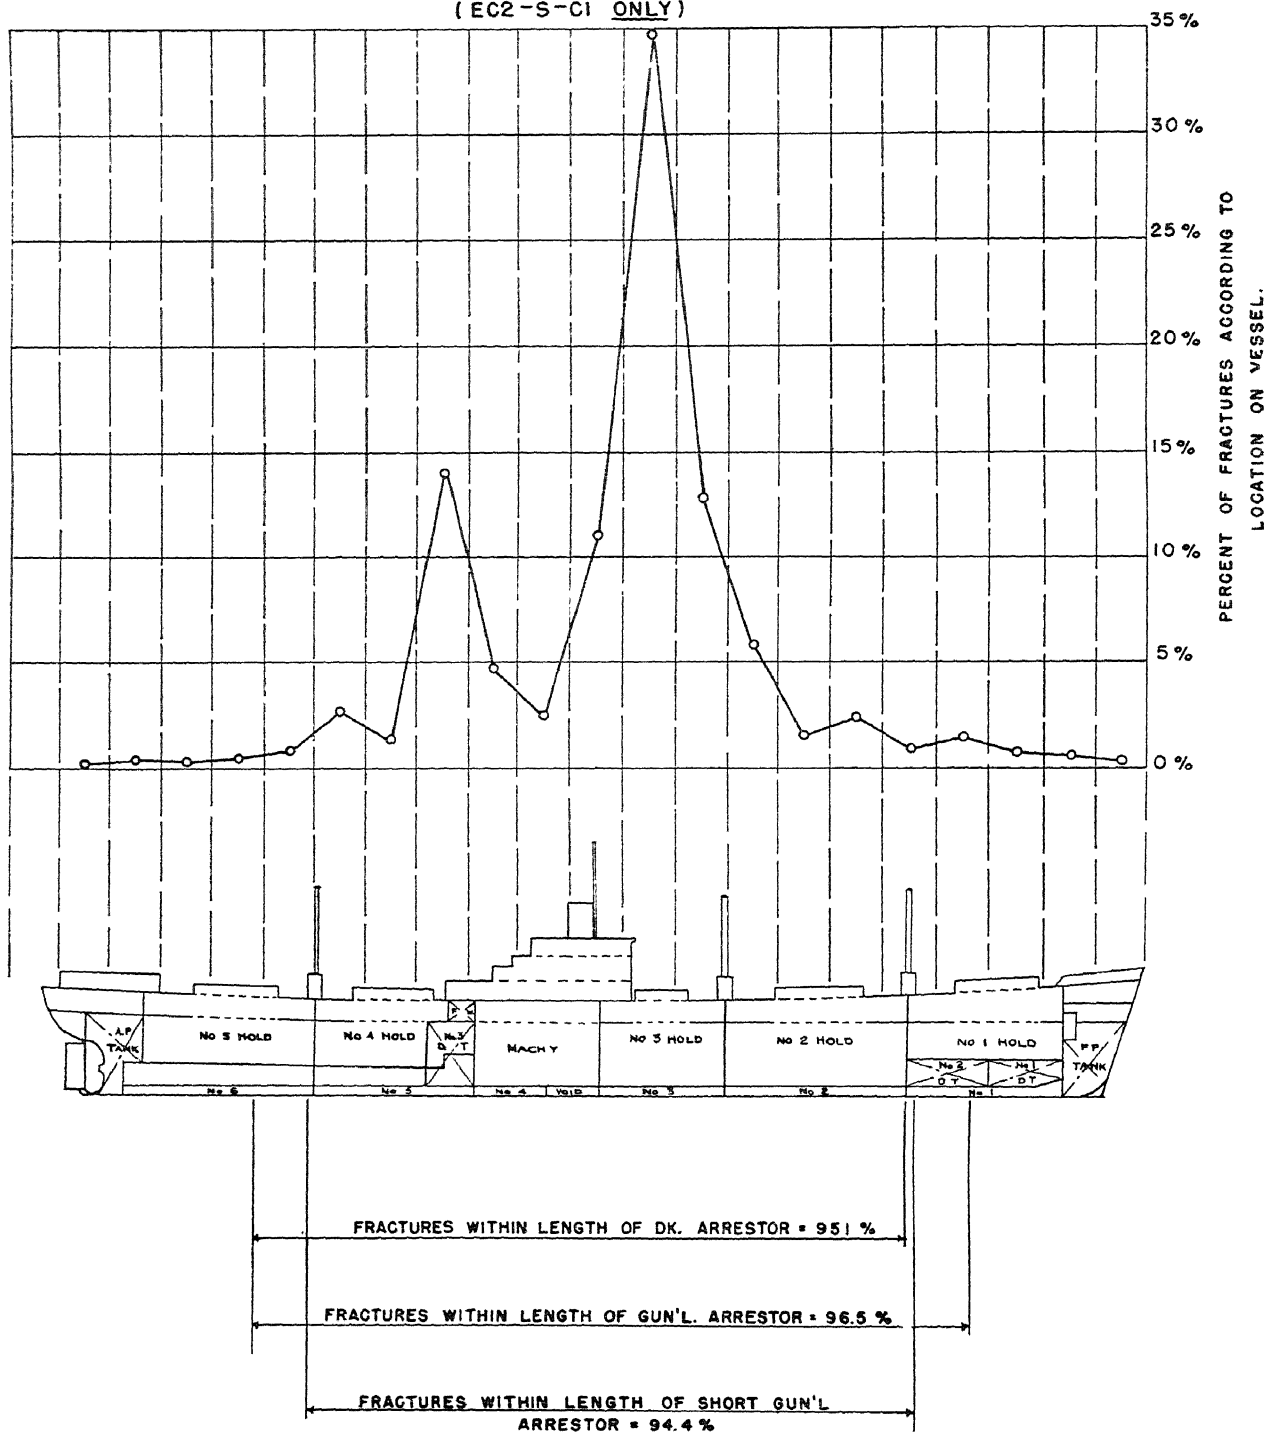
Figure 49.

THIS DRAWING IS BASED ON 1736 FRACTURES IN ALL PARTS OF LIBERTY SHIP STRUCTURE AND REPORTED BEFORE 17, OCT. 1944.

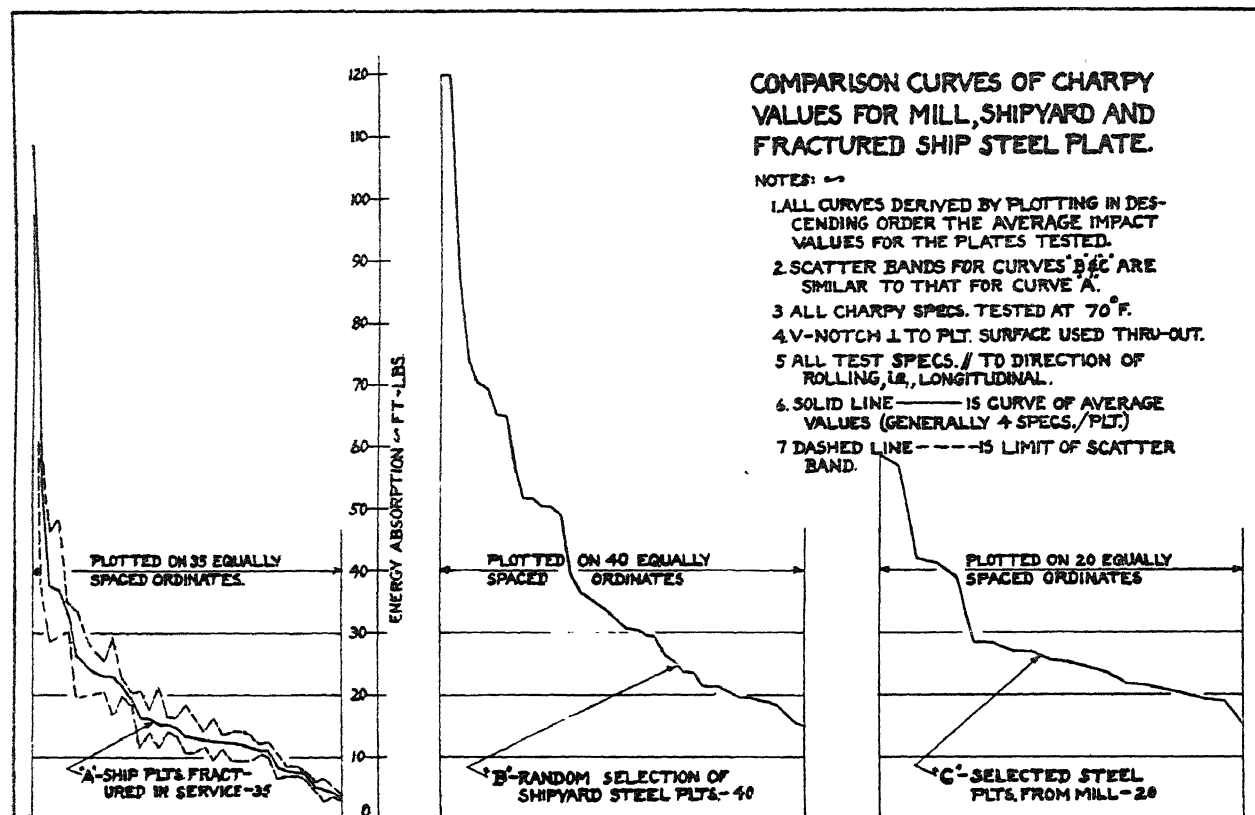
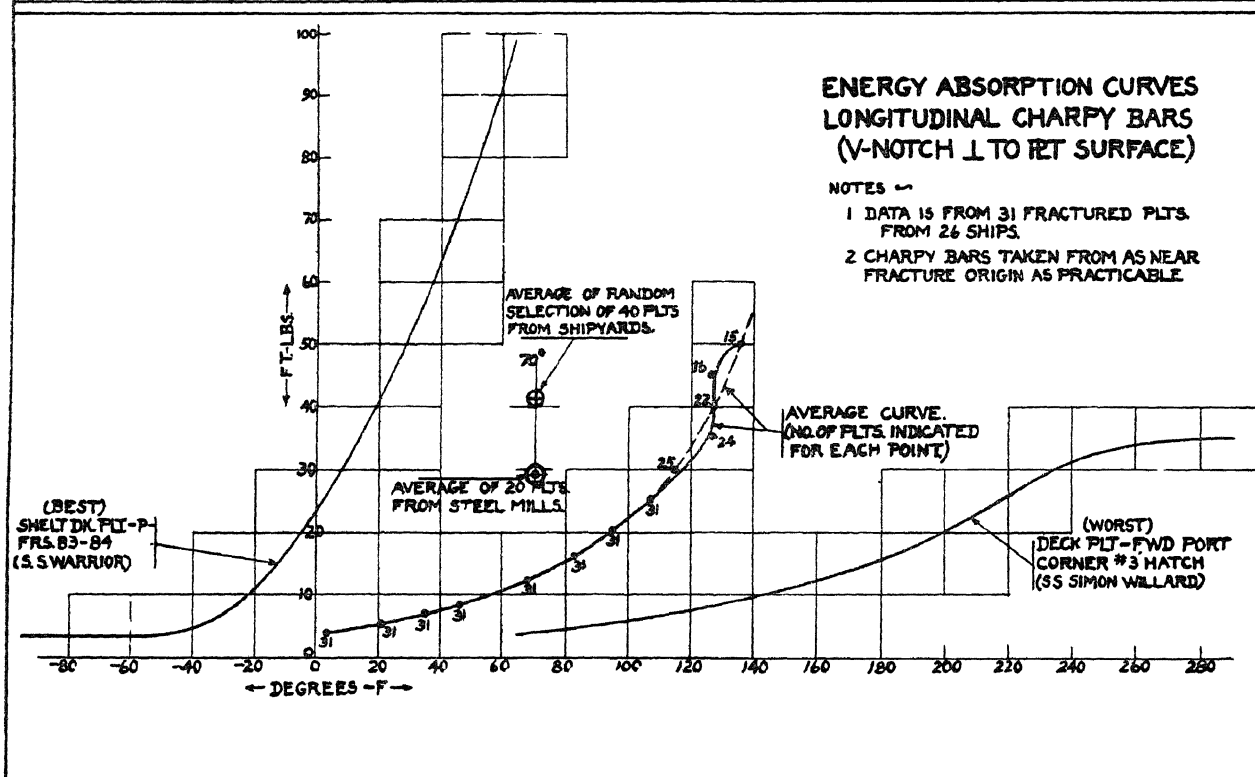
Figure 57.

Data for the 31 plates have been averaged with respect to temperature: the averages are shown in the lower portion of figure 57, along with the best and the worst curves. The energy absorption values at 70° F are also indicated for each of the plates tested (upper left) with dotted lines to indicate the spread of the energy absorption values covered by the four specimens tested at that temperature.

Data from Groups B and C have been entered in the temperature diagram on figure 57 and comparison suggests that specimens of steel in Group A (from fractured plates) were more notch sensitive than

Figure 57 shows that the steel in fractured plates loses the ability to absorb energy in the notched condition as temperature goes down. Low temperature is said to increase the notch sensitivity of the steel. Experience also shows that fractures in service gain in frequency at lower temperatures. It would be

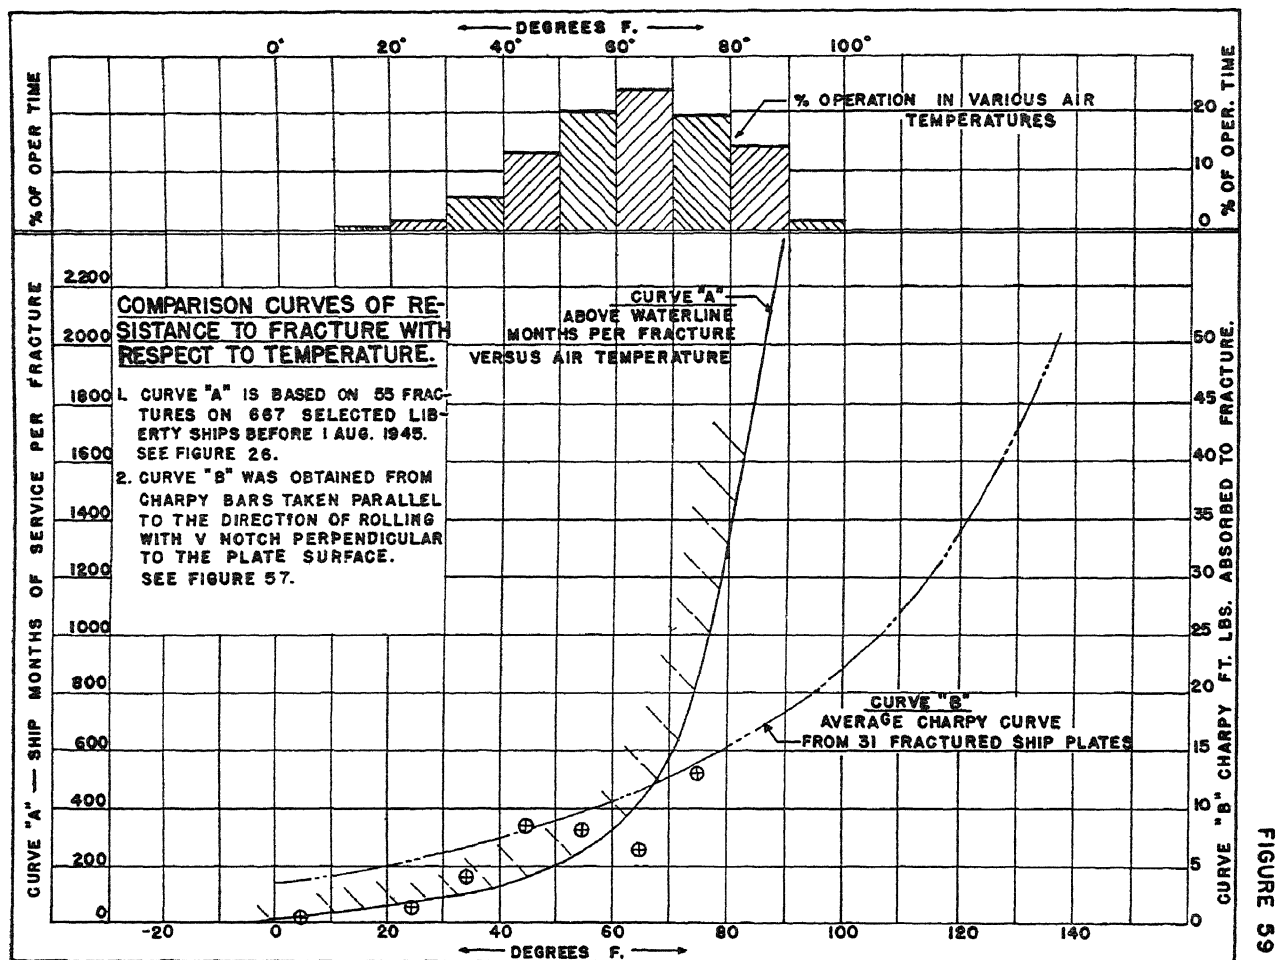
Figure 59.

This similarity is shown in figure 59 where the average curve for Group A from figure 57 is superimposed on another curve drawn from the data on service fractures. This second curve was obtained by plotting ship months per fracture, the simple reciprocal of the quotient "fractures per ship month" in figure 26. When these two curves are brought together, it appears that the ships lose heavily

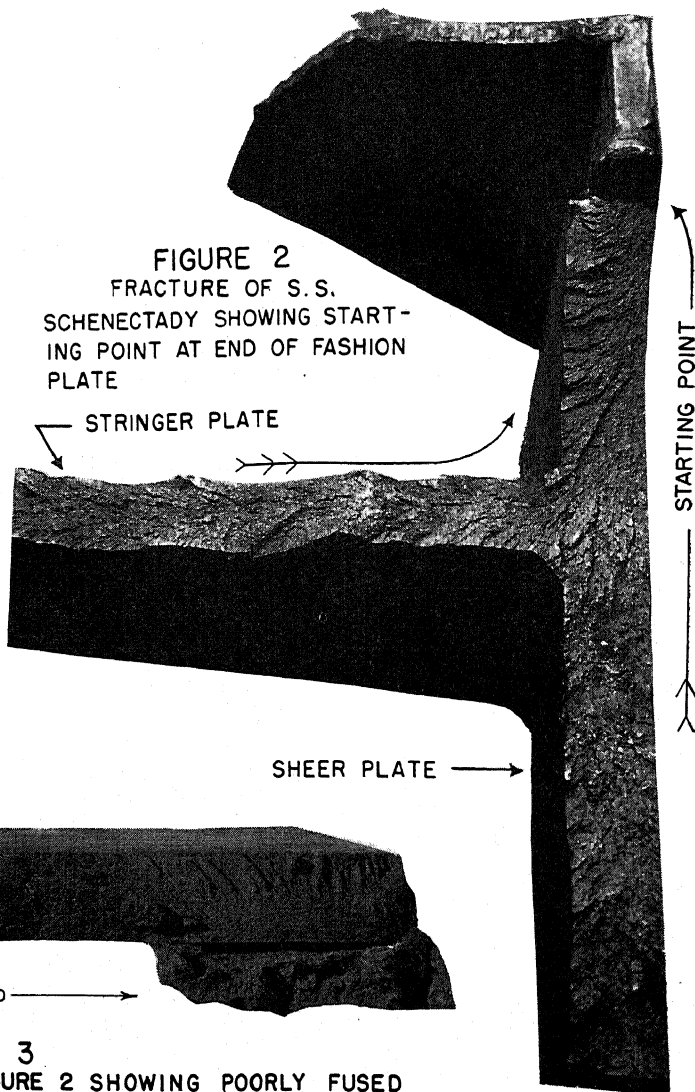
FIGURE 60.

FRACTURED 51\* DECK PLATE FROM FIGURE 2 SHOWING POORLY FUSED WELD IN UPPER FLANGE OF LONGITUDINAL HATCH SIDE GIRDER.
